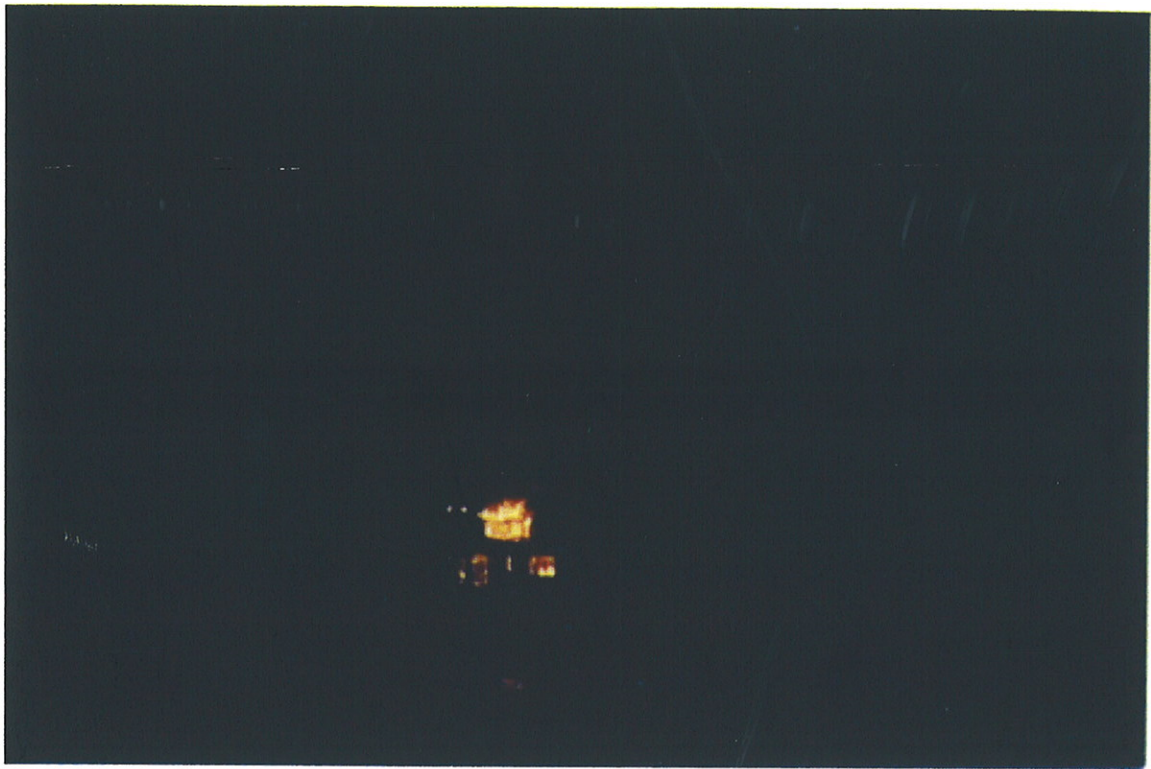
**Photo 1: Mr. Marino's first photo depicting the magnitude of fire within the carriage house.**

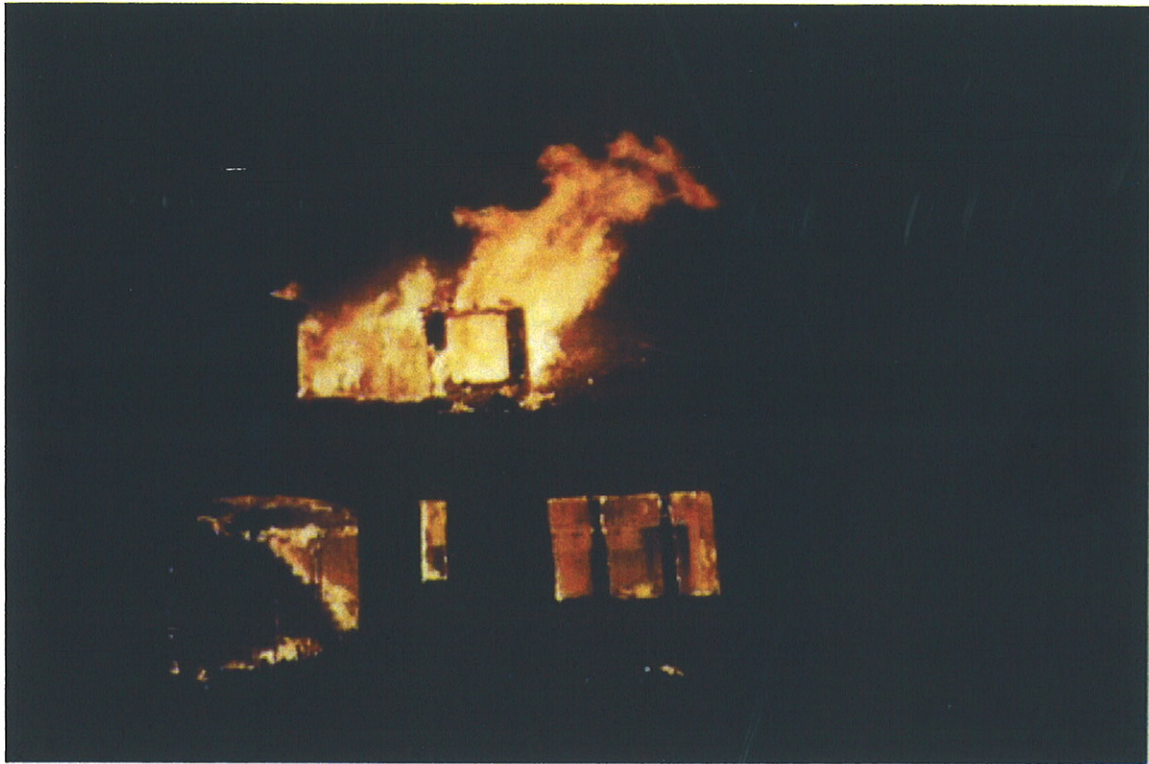
**Photo 2: Mr. Marino's 5<sup>th</sup> picture taken of the carriage house showing fire spread from the kitchen. Note that the kitchen burning has "decayed".**

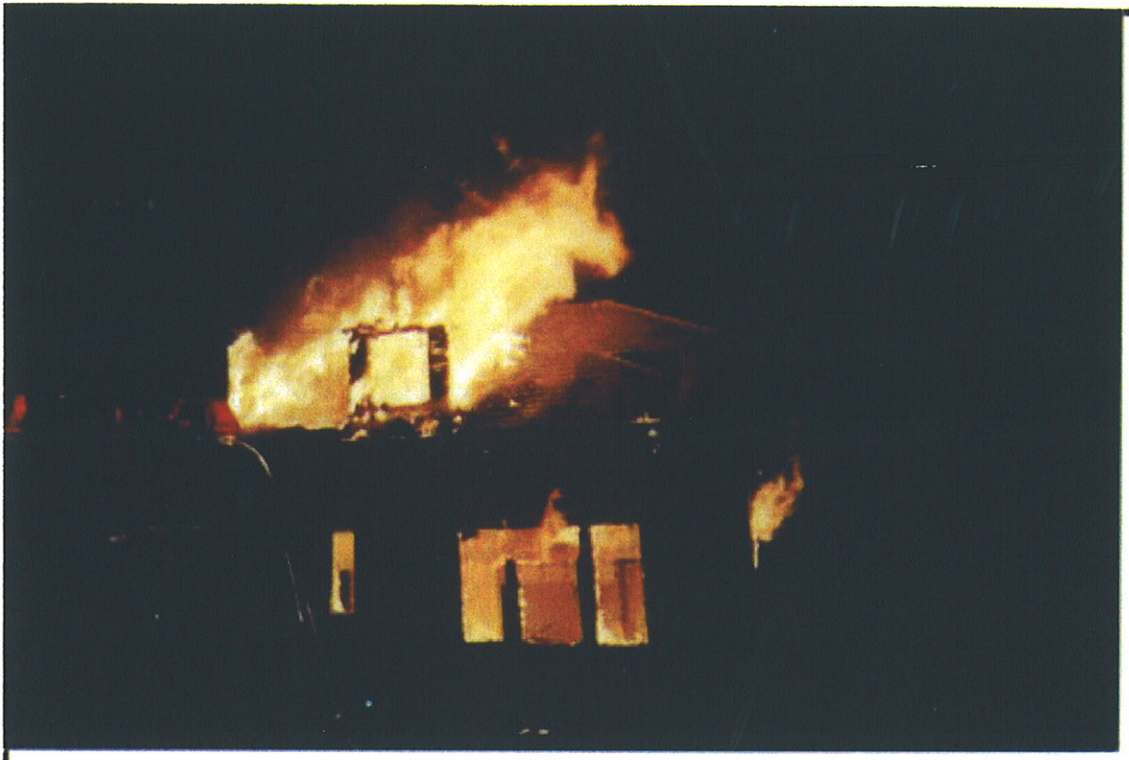
**Photo 3: Mr. Marino's 9<sup>th</sup> photo taken depicting further spread to "connecting" second floor dormer area and horizontal fire spread to other areas of the carriage house.**

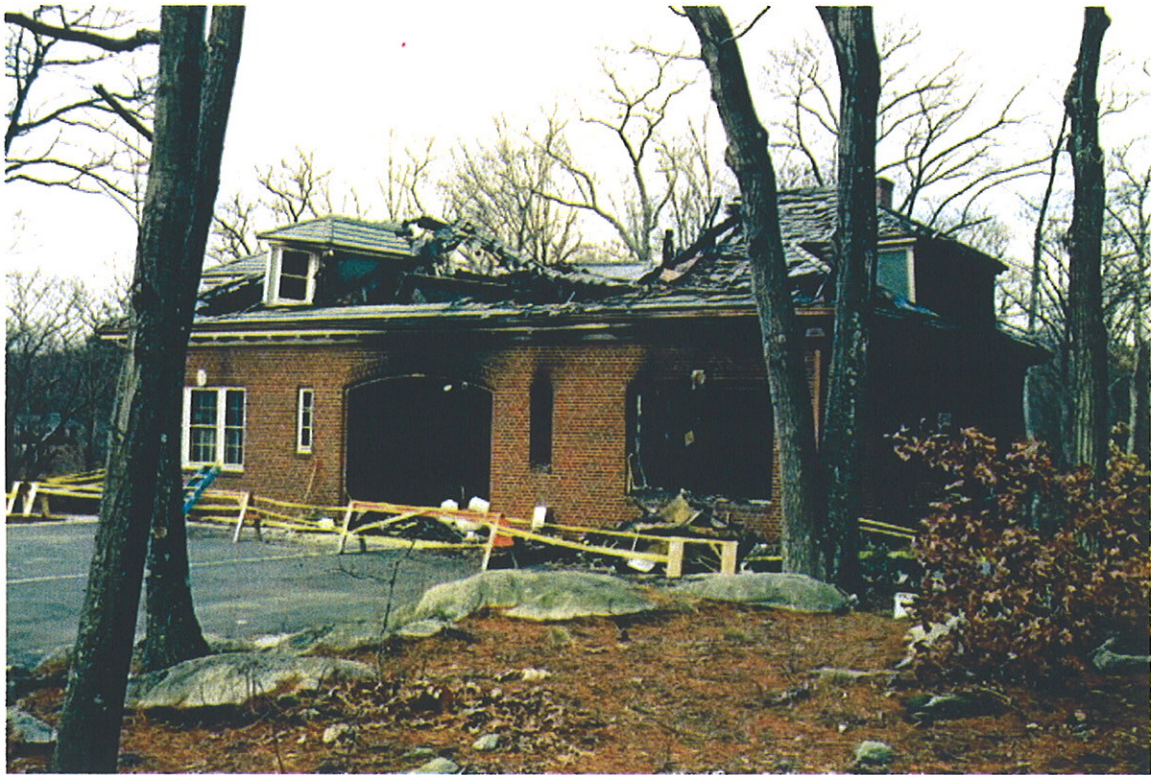
**Photo 4: Exterior view of “south” wall of carriage house showing location of main entryway, kitchen and second floor dormer (consumed).**

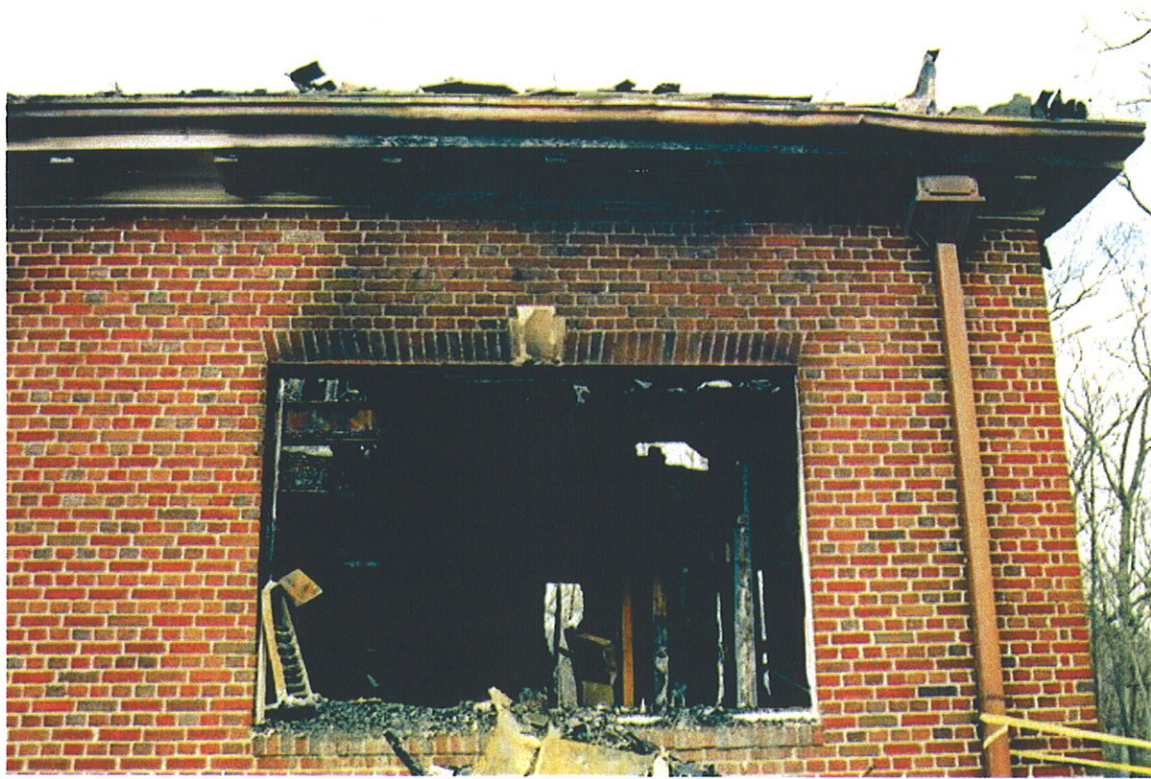
**Photo 5: Kitchen window opening and significant extension of fire from kitchen window to eave portion of roof. Note: this fire extension occurred before any of Mr. Marino's photos were taken.**
